ETEVÄ-BRIDGES:

***Structural robustness of post-tensioned bridge in
case of tendon failure***

Presentation 20.11.2024

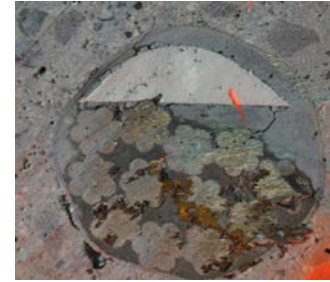
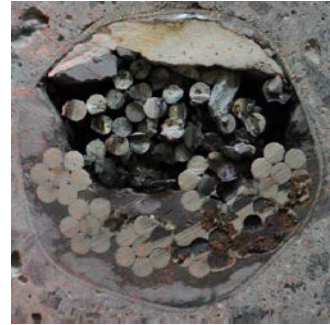
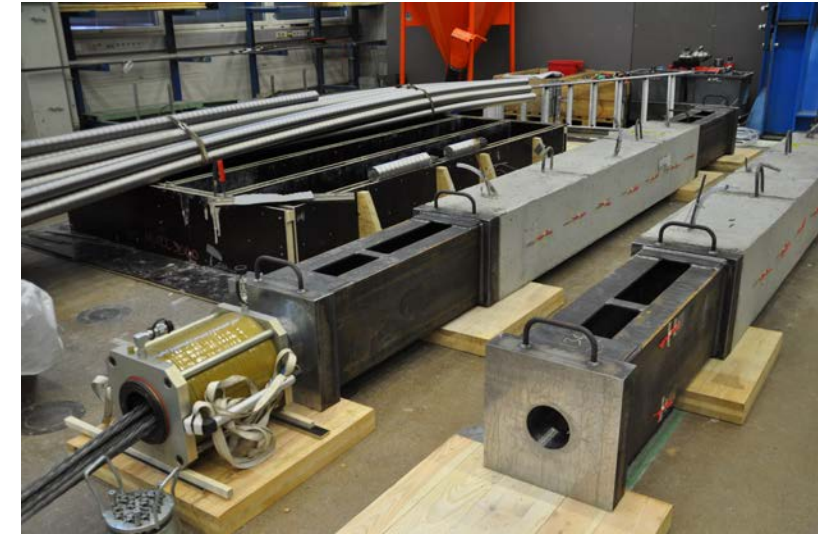
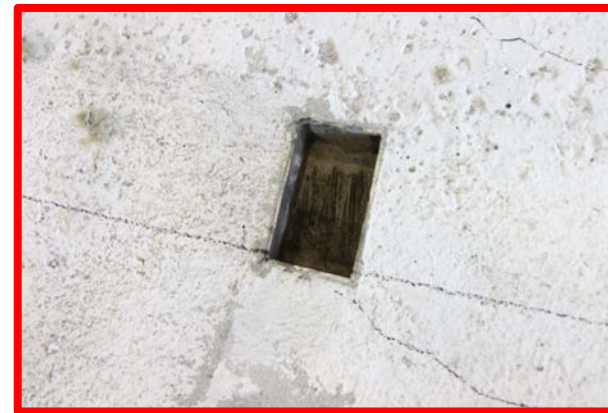
Experimental research

Notch at middle support top to flame cut the strands

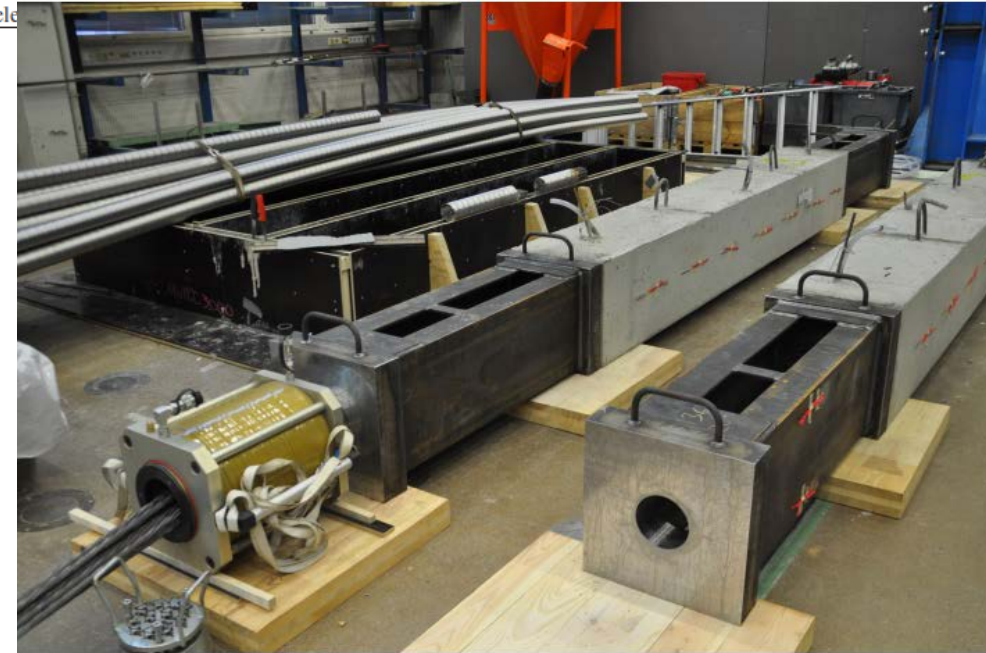
Key results:

- Re-anchoring length and calculation method for bundle of strands in complete and incomplete grout, verification and parameters for calculation
- Verification of the effect of overlapping bond and re-anchoring lengths
- With poor grouting the re-anchoring length increases from **1.3 meters to 1.7 meters.**

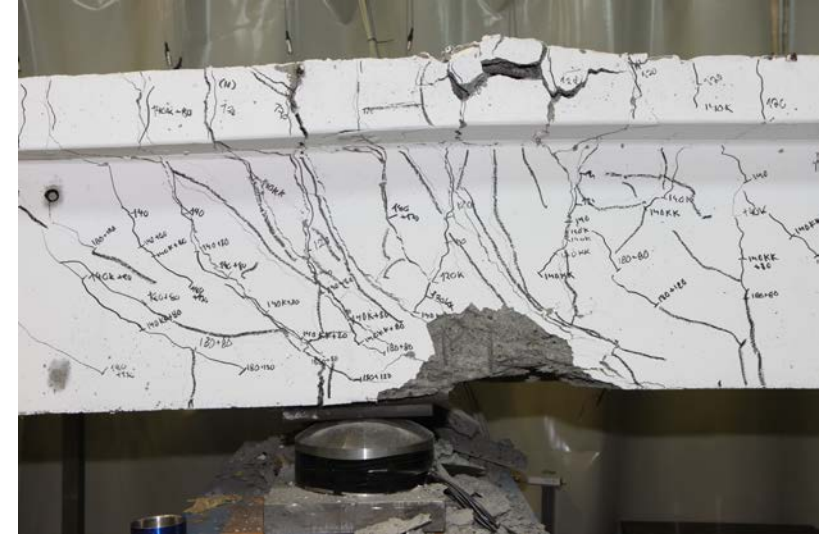
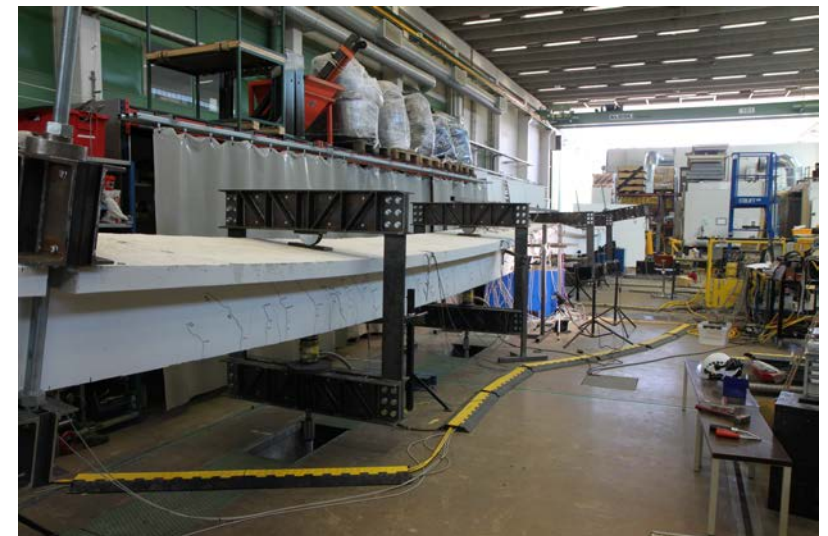
Key Results:

- Strong moment redistribution from middle support to field, due to tendon reduction in ULS.
- Low utility ratio of bending moment in field while ultimate at support
- The amount of reinforcing steel has beneficial effect on robustness and ductility
- Recommendations and simplifications for analysis purposes

Hogging

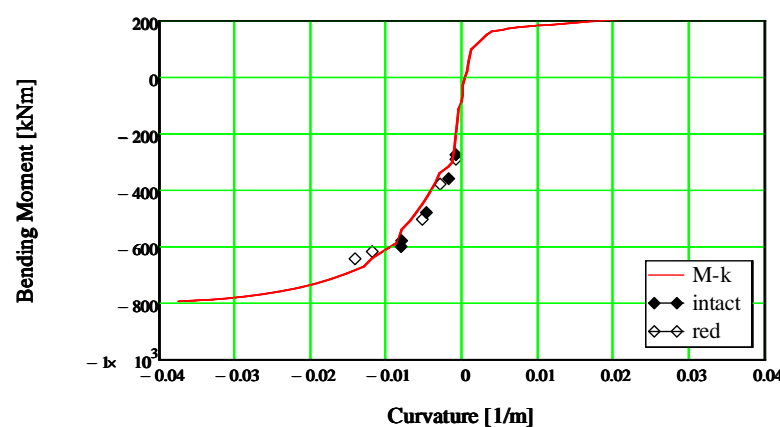
Sagging

F=1040 kN
